Marine Renewable Energy MRE2
Annual Report

Individual Consequences of Tidal Turbine Impacts

Sea Mammal Research Unit
Report to
Marine Scotland, Scottish Government

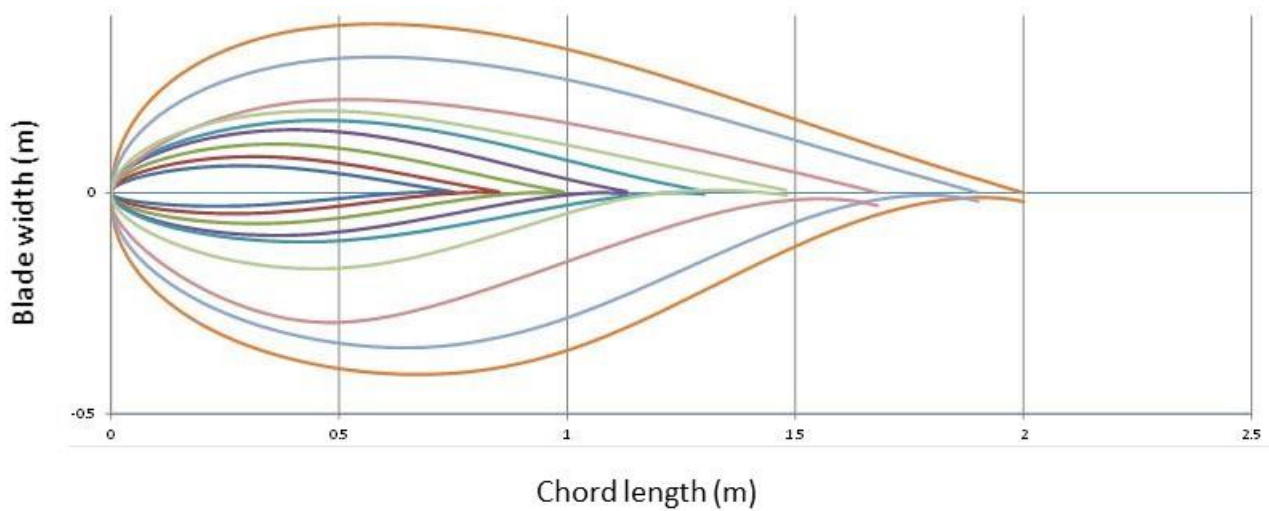
Figure 2. Scale drawings of the profiles of a typical tidal turbine blade at different distances from the centre. Widest profile is at 3m from the centre and profile becomes progressively narrower towards the tip. In reality, the profiles are progressively twisted but this has been removed to make it easier to compare profiles.

The blade tip was used for the model as it has the “sharpest” leading edge profile and the smallest frontal surface area, it therefore represents the most potentially dangerous part of the blade due to the narrower and therefore smaller area impact zone. For example, a typical 9 m turbine blade displays a 2 m chord at its widest point, 3 m from the blade root at a twist angle of 10.8° compared to a 0.75 m chord at a twist angle of 4° at the tip (Figure 2). Furthermore, the tip speed of a rotating object represents the fastest moving part and therefore will always represent the most potentially damaging area for a collision to occur.

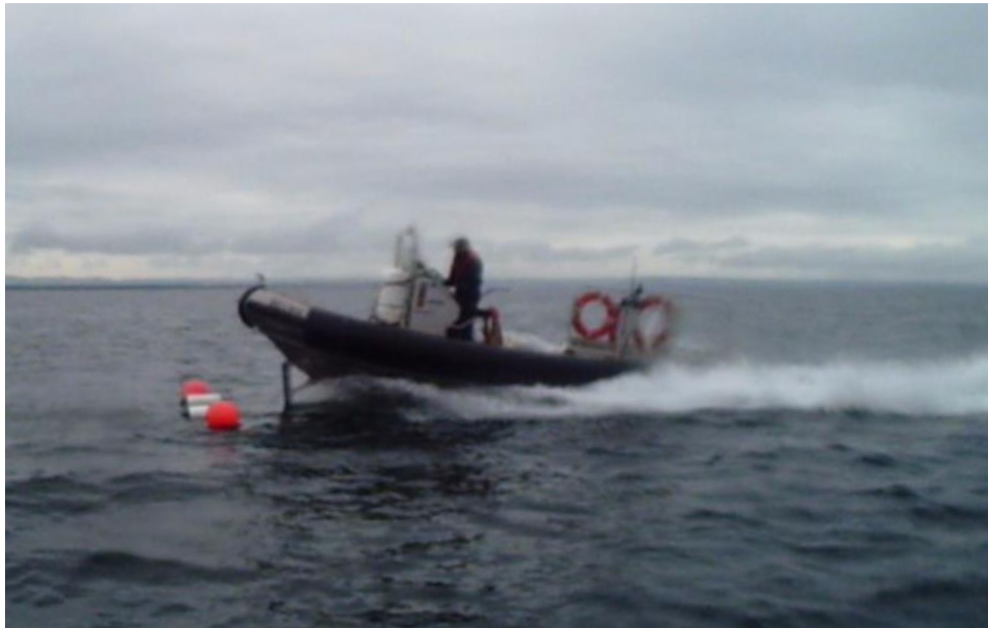
Figure 5. A collision trial immediately prior to impact. Note the orientation of the blade on the keel of the boat as being almost exactly perpendicular to the water line.

The development of the new blade mounting design allowed a perpendicular deployment angle so no additional corrections in the observed collision speeds were necessary. The speed of the collisions was taken as the GPS derived speed of the boat at the moment of impact. Figure 5 shows the deployment angle of the blade while the boat was in motion. Table 1 details the locations and speeds of each trial.

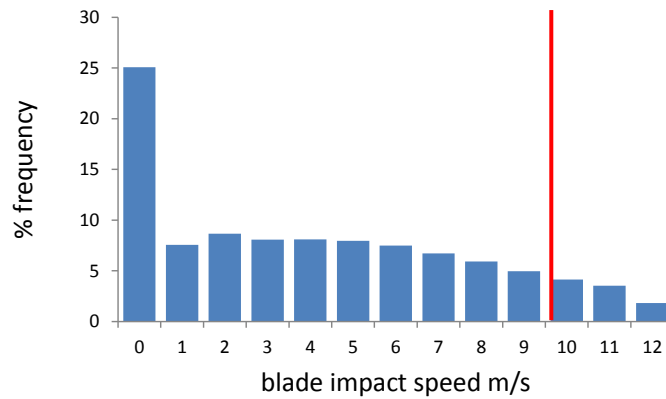
Figure 7. Frequency distribution of estimated blade speeds during collisions with randomly moving seals (Data provided by EWTEC). The red line indicates the minimum collision speed in these trials. All collisions above this value produced fatal injuries.

To illustrate the combined effects of the temporal patterns of flow and the position on the blade a frequency histogram of expected collision speeds was generated (Figure 7). The POLPRED package was used to generate estimates of the current speeds at 10-minute intervals over the period from the 4th of March to the 1st of April, 2014, for a site in the Sound of Islay. These current data were used to generate estimates of the blade speed, assuming that the turbine stalls at a current speed of 0.8 m.s^{-1} and reaches a maximum tip speed of 12 m.s^{-1} for current speeds of 2.5 m.s^{-1} and higher. This is broadly similar to the pattern for the SeaGen device in Strangford. Figure 7 shows the frequency histogram of estimated blade speeds for collisions with seals swimming randomly with respect to the turbine position. It is apparent that most collisions would be with relatively slowly moving blades. Under these assumptions, the blade speed in the majority (>90 %) of collisions would be less than 10 m.s^{-1} .
